## **FRANKLIN HIGH SCHOOL**

### **Franklin High School Existing Conditions Review**

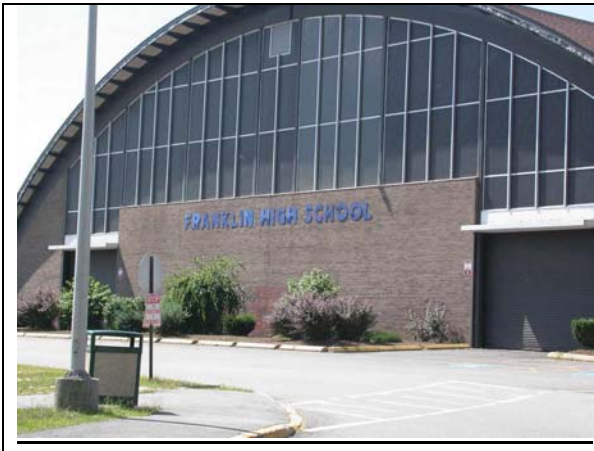
### **FIELD HOUSE**

There are significant concerns about the condition of the field house roof and structure. See the structural report for more details. The resilient athletic floor is deteriorating and support spaces are entirely inadequate and in poor, non-handicapped accessible condition.
